KIRKWOOD LAKE DAM  
NJ 00399

6 PHASE 1 INSPECTION REPORT  
NATIONAL DAM SAFETY PROGRAM.

11 August, 1979

7. AUTHOR(s)  Jolls, F. Keith P.E.		6. PERFORMING ORG. REPORT NUMBER
9. PERFORMING ORGANIZATION NAME AND ADDRESS Louis Berger & Associates 100 Halstead Ave. East Orange, N.J. 07019		8. CONTRACT OR GRANT NUMBER(s)  DACW61-79-C-0011

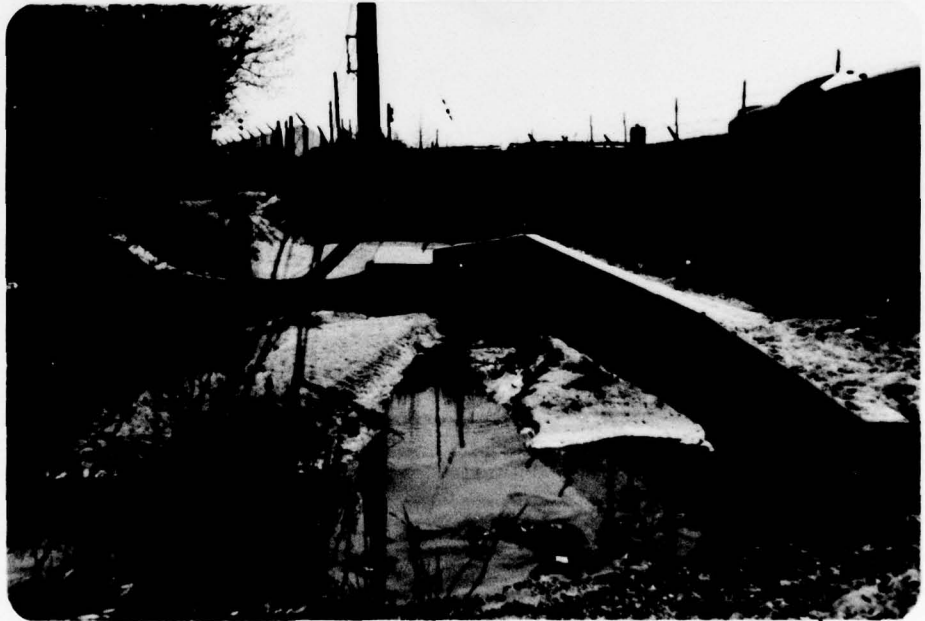
The concrete spillway, although buttressed against the old stone masonry abutment walls is in no immediate danger of collapse unless the embankment is scoured out on each side. Further, during most severe flooding conditions, there is apparently a backwater condition caused by the partially-blocked elliptical CMP culvert under the roadway embankment just 100 feet downstream. However, surface run-off from the crest is slowly scouring out the backslope fill behind the bridge wingwalls and together with the two storm drains from the railroad property have created a stilling basin between the dam and the roadway embankment.

View of Stilling Basin

(4) Heavy stone should be placed in the downstream stilling basin in selected areas to prevent further scouring and preclude the undermining of the bridge structure.
